### POLYURETHANE VS. SILICONE SEALANTS

**Structure:** Multi-Story Office Building; Granite panels and large expanses of glass

**Problem:** Air and water infiltration at windows and panels

**Solution:** Complete re-caulking of panel and glass system joints

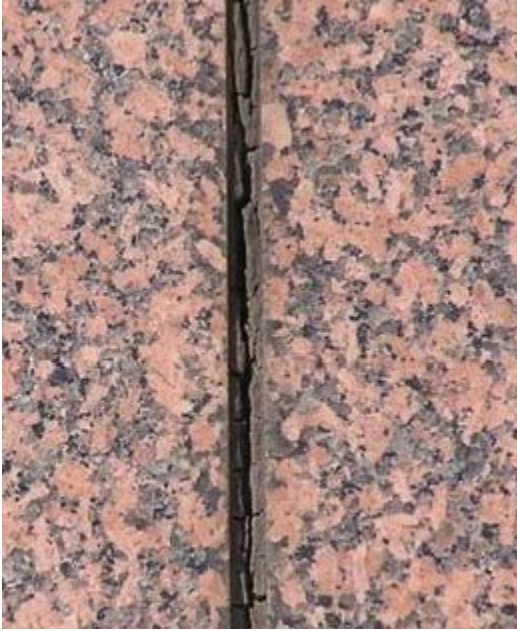
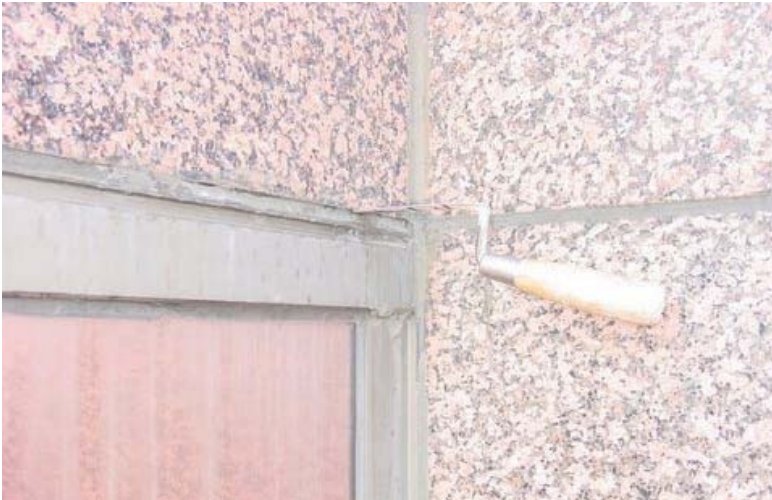
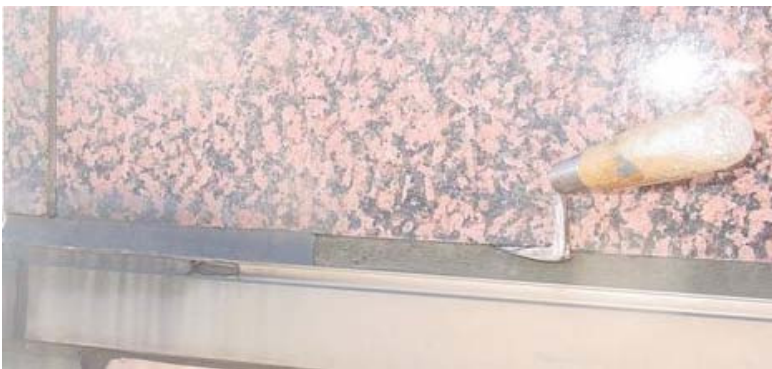
This building was constructed 25 years ago and sealed at

that time with a polyurethane sealant, which has exceeded its life expectancy by perhaps 10 years. The signs of sealant aging and deterioration include cracking, alligatoring, and reversion (where the sealant, over time, loses its ability to actually seal joints): the sealant in place on this building exhibited all these conditions:

This building required a sealant with high UV stability, flexibility over a wide temperature range, and the ability to accommodate extreme joint movement. After careful consideration, it was determined that a silicone sealant would be used to replace the original sealant. Our biggest concern on this project was joint movement. There is a range of panel joint size on this building from narrow to wide; the narrow joints concerned us most:  $\frac{1}{4}$ " of joint movement, for example, puts more stress on a  $\frac{1}{2}$ " joint (50% movement) than on a  $\frac{3}{4}$ " joint (33%), which a silicone sealant is better suited for.

After sealant selection, the next critical step in a re-caulking project is determining the installation procedure. Owners and Architects must work with the contractor/sealant manufacturer team to determine proper joint preparation and sealant installation procedures for each joint substrate condition. For example, in the case of the panel to panel joints on this project, it was decided that in order for the new sealant to adhere properly the existing sealant would be removed in its entirety: after sealant removal the joint substrates would be ground down and the joints would be solvent wiped per the manufacturer's recommendations, prior to the installation of new sealant.

The same decision process was followed on all joint substrate combinations of this job: panel to panel, panel to metal window, and glass to metal window joints. No sealant choice or installation procedure was implemented or even specified without first making sure it was per the manufacturer's recommendations and then installed and tested (via sealant pull tests) by the manufacturer's representatives.
